# New York State Department of Transportation

## Yellow Flag NB2228W013

**BIN: 1065318**

Yellow Flag No. NB2228W013

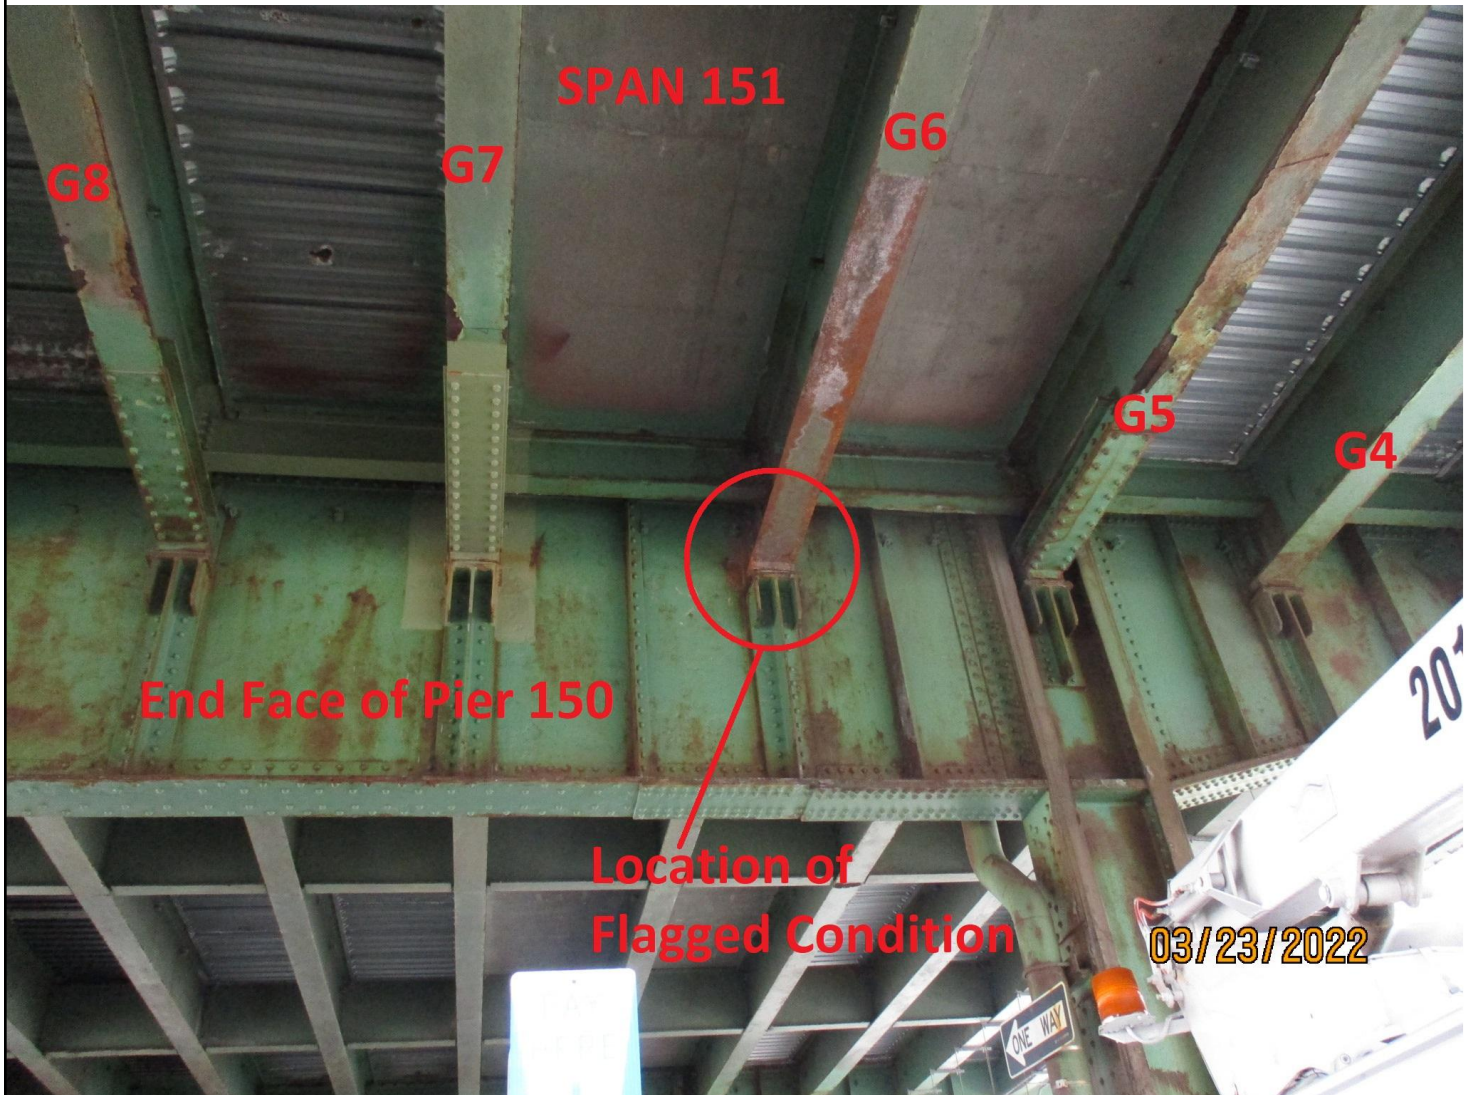
Photo Number: 1

**Attachment Description:** General view of the flagged condition at Girder G6 in Span 151 at Pier 150. Looking Begin.

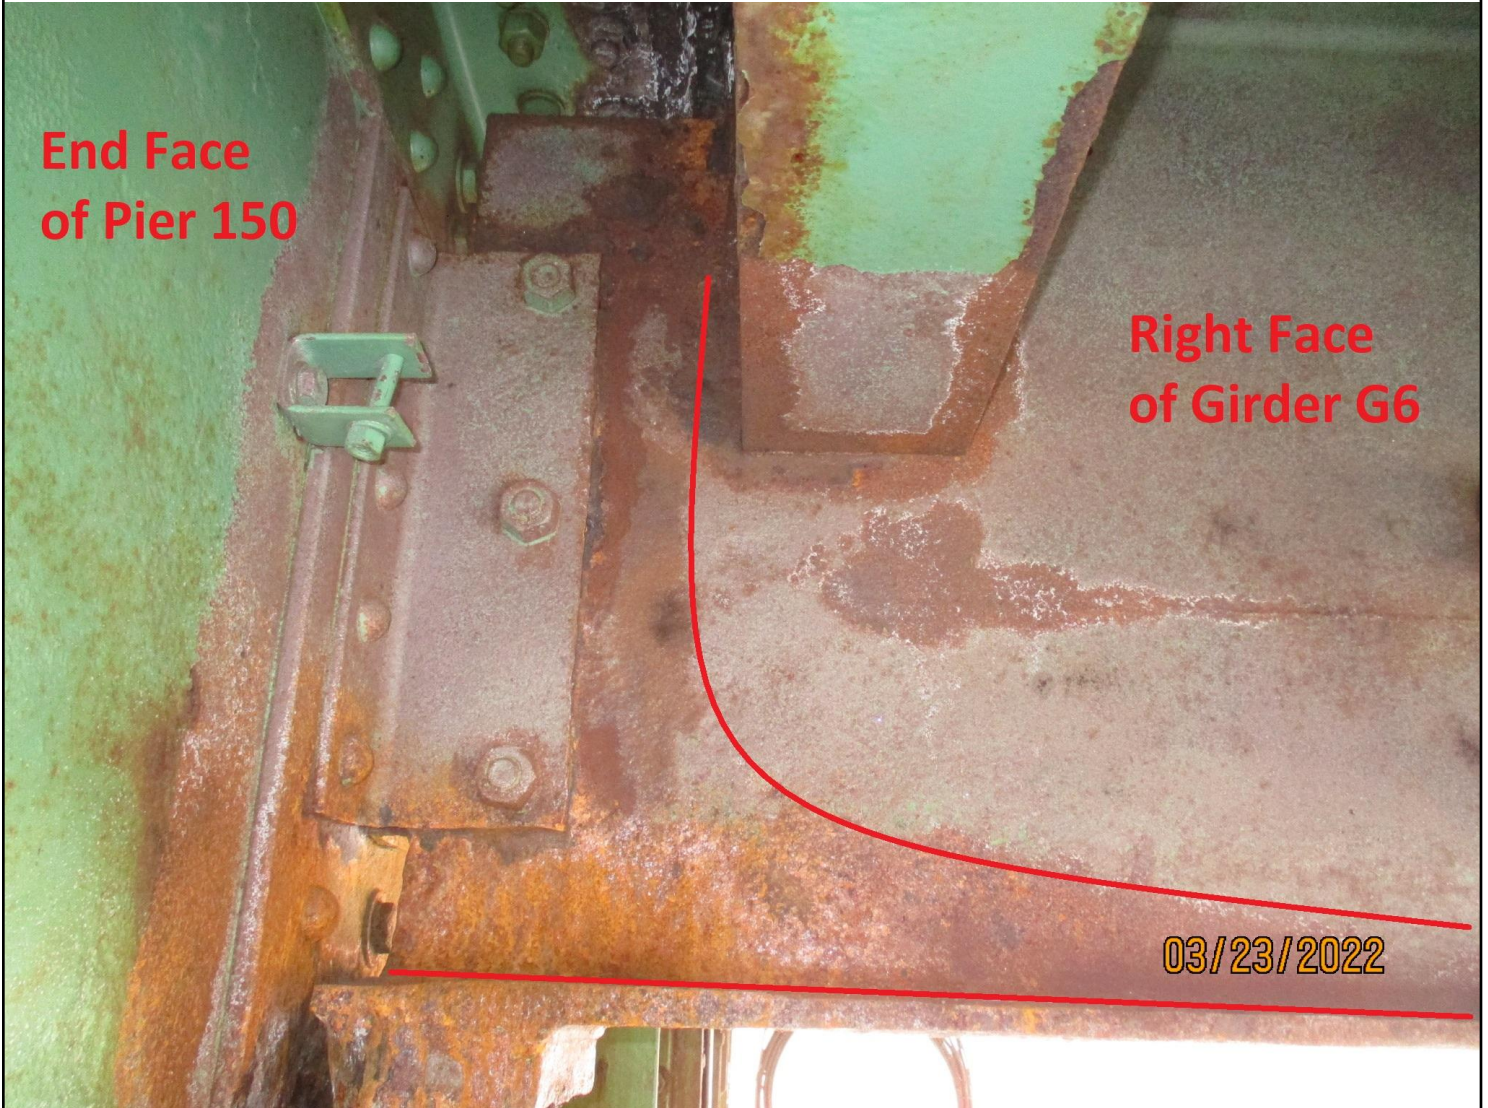
Photo Number: 2

Description: The end of Girder G6 on Span 151 side of Pier 150 exhibits severe corrosion resulting in an overall lower web bearing area section loss of approximately 53% (previously 55%) and an overall shear web area section loss of approximately 50% (previously 35%) with a localized average web section loss of approximately 68% (previously 66%) for 4" high directly above the bearing (Photos 2 and 3).

**Attachment Description:** The right face of Girder G6 in Span 151 at Pier 150. General view of the corrosion and severe section loss at the girder web. Looking Left. (Note Sand blast cleaning since the previous inspection).

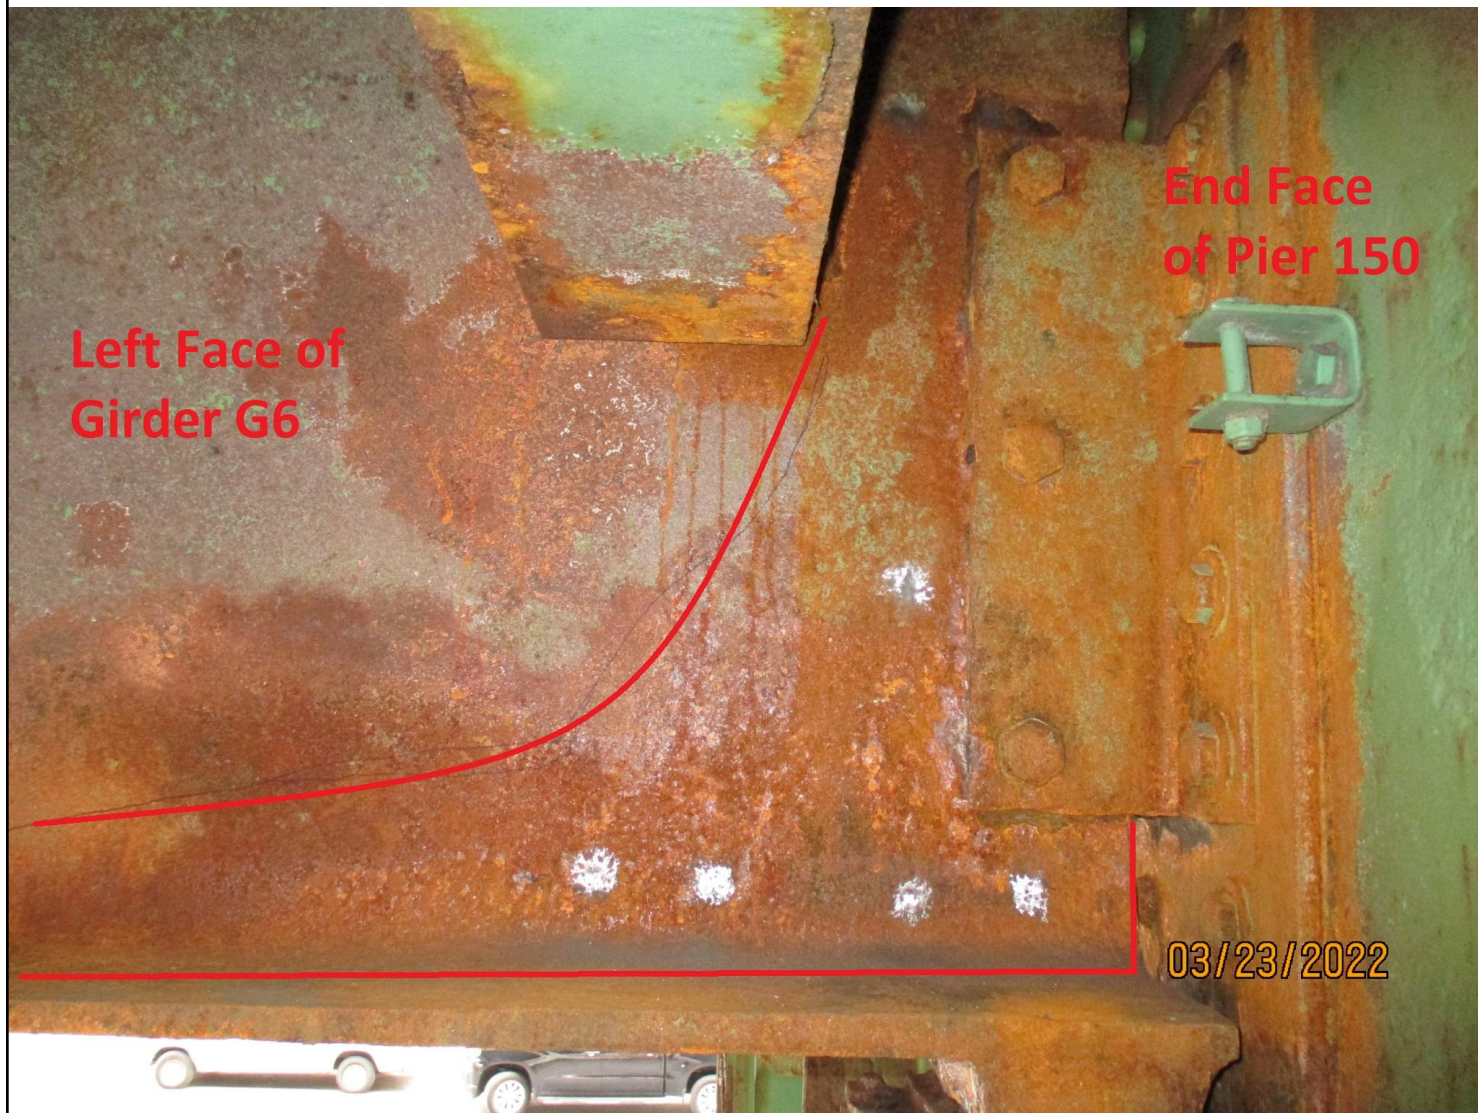
**Attachment Description:** The left face of Girder G6 in Span 151 at Pier 150. Close up view of the corrosion and severe section loss at the girder web. Looking Right. (Note sand blast cleaning since the previous inspection).

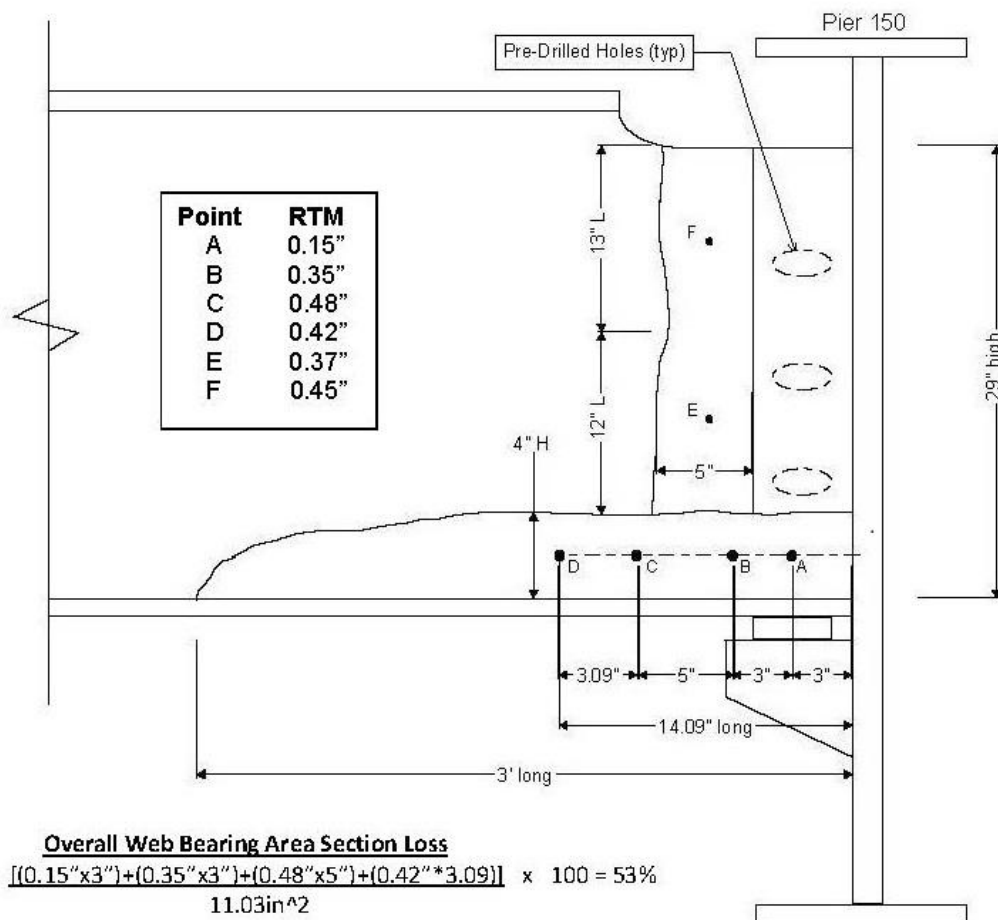
Photo Number: 4

The remaining thickness measurements (RTM), as measured with a D-meter, for the full height of the web were taken adjacent to the guide angles at both faces of the girder as the RTM were unable to be taken directly behind the guide angles.

**Left Face of Girder G6 Sketch in Span 151 at Pier 150**  
**N.T.S**

**Attachment Description: 2022 Girder Section Loss Sketch**

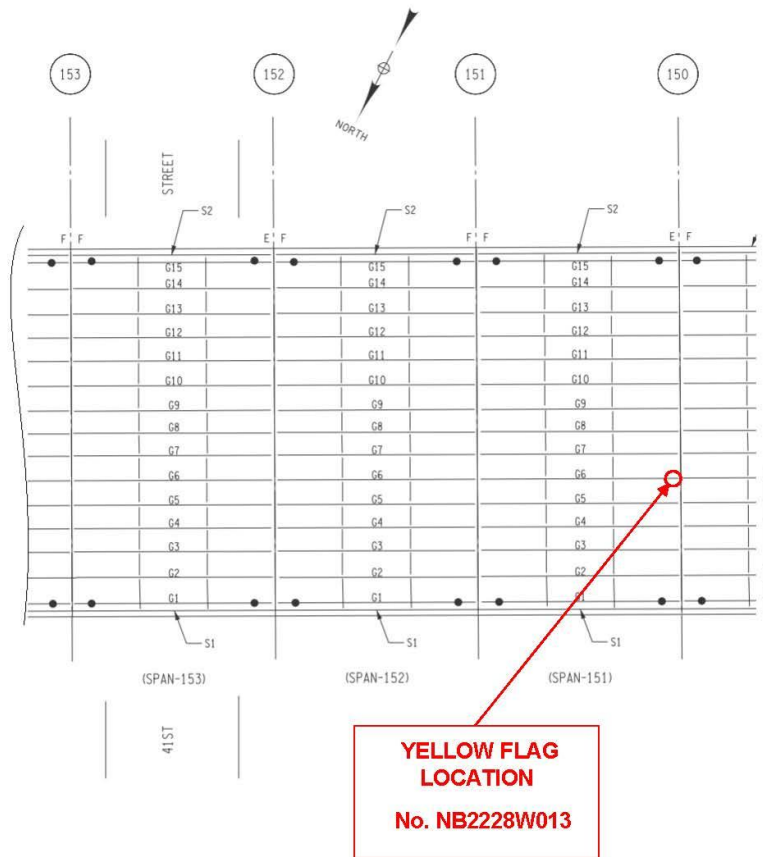
Photo Number: 5

**Attachment Description: 2022 YF Location Framing Plan**
